INDEPENDENCE TOWNSHIP INVENTORY

Address 7600 Allen Rd **Site No.** 17-04
Governmental Unit Independence Township **Sidwell No.** 08-17-300-019
County Oakland

Original Usage Farmstead
Present Usage Single-family residence

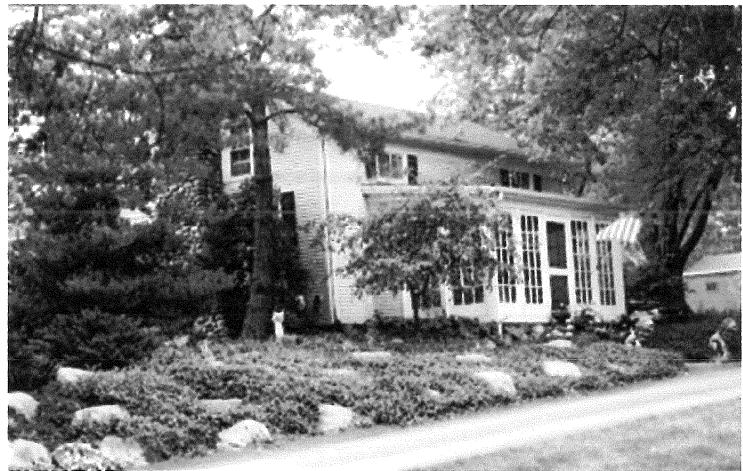
11. Residence

Description Side-gabled Greek Revival house with a rubble stone foundation and chimney, and a pair of frieze band windows. Anachronistic features include vinyl siding and an enclosed front porch (added since 1991). Only two of the original nine-pane-over-six windows remain in the living room. Their interior trabeated window frames are distinctly Greek Revival in style. Two upstairs bedrooms were remodeled and the first floor bath and stairs were added in 1935. Further additions were made in 1956.

Date of Construction house-1845; barn-1900; additional farm structures-1935
Condition all structures-good
Integrity all structures-good

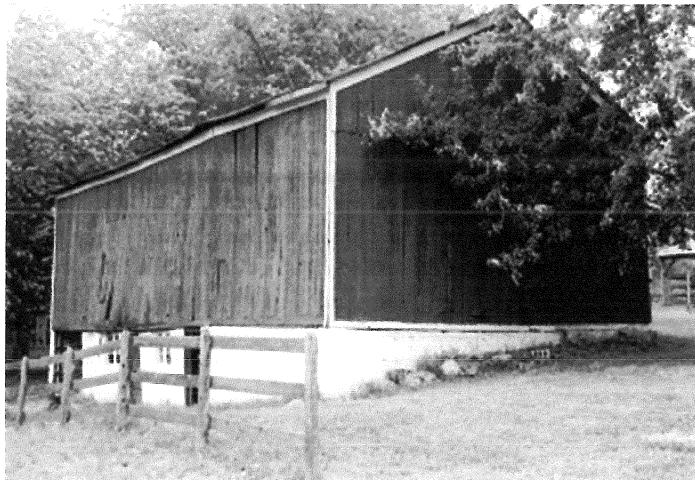
12. Tool shed, duck house and chicken house

Also located on the property are several farm structures including a barn with a gable roof and rubble stone/concrete block foundation; a tool shed; a duck house; and a chicken house.

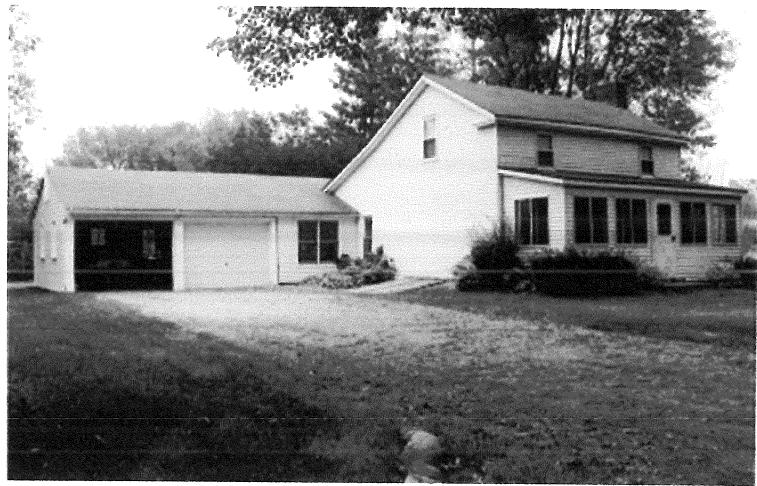
Description Side-gabled Greek Revival house with a one-story addition to the rear (1936), an attached two car garage addition (1905), an enclosed porch, and anachronistic exterior siding. The house lacks the wide trim band which typically emphasizes the cornice lines of Greek Revival houses.

Condition good

Integrity poor

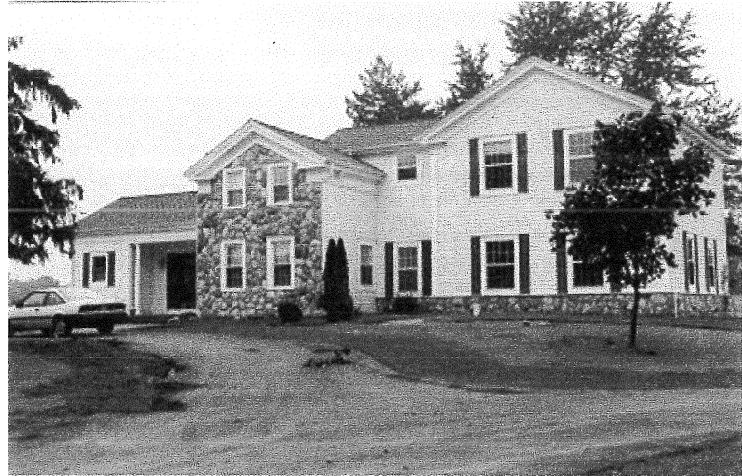
16. Residence

Description This house has recently undergone significant renovations. The original house was a gable-front-and-wing Greek Revival house with a rubble stone foundation and a recessed front porch. Changes to the building that have occurred within the last year include the dramatic two-story addition to the north, which includes a garage on the ground level, and the application of a rubble stone exterior to the original gable front. These alterations have seriously effected the historic integrity of the house.

Date of Construction house-1855; barn-1885
Condition house-good; barn-good
Integrity house-poor; barn-good

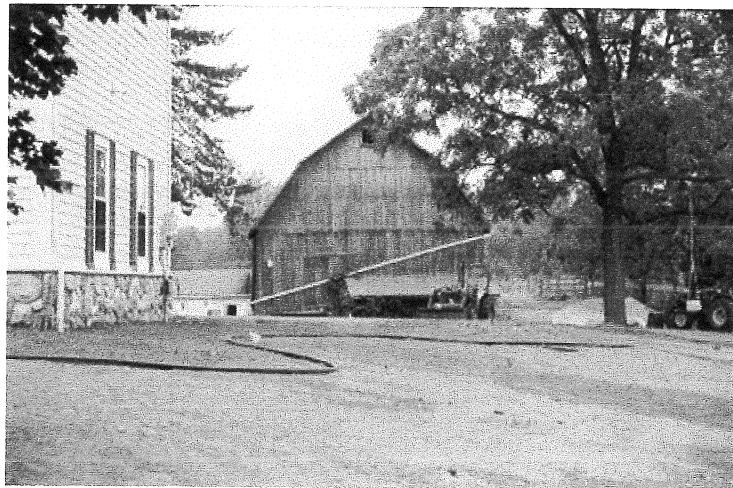
17. Barn

Also located on the property is a barn with a rubble stone foundation and gambrel roof.

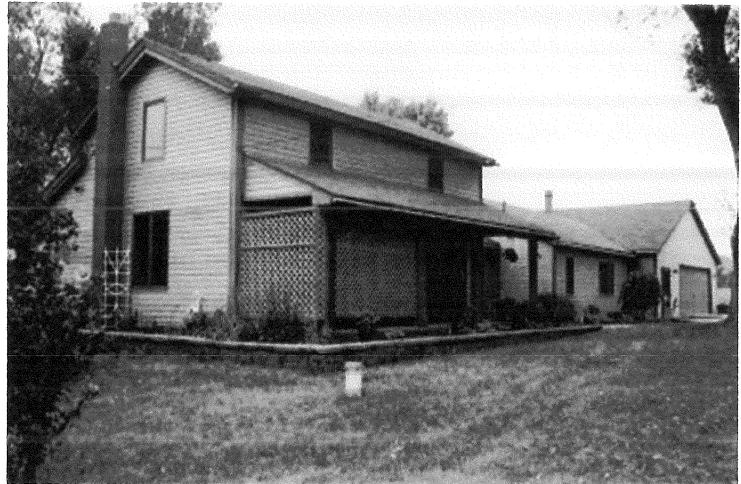
Description Two-story side-gabled Greek Revival house with a pair of freize band windows (minus the freize band), a one-story addition to the west and a rubble stone foundation. There have been many anachronistic changes to this structure including vinyl siding, a covered front porch, an attached garage and a one-story addition connecting it to the main house, and several window and door changes. In addition, the house lacks the wide trim band which typically emphasizes the cornice lines of Greek Revival homes.

Condition good
Integrity poor

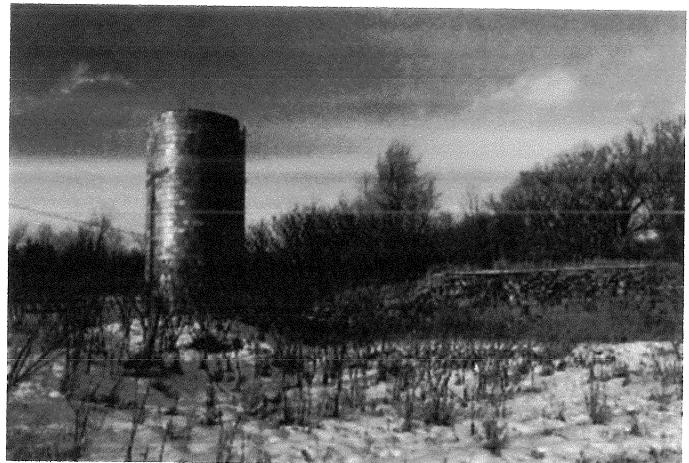
Description All that remains on this property are the rubble stone ruins of a barn and an adjacent concrete and tile silo.

Condition barn-ruins; silo-fair (missing cap)
Integrity barn-poor; silo-fair

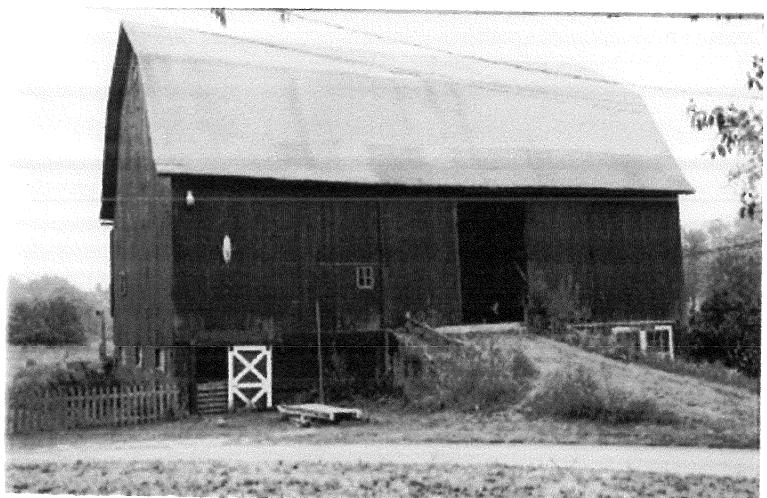
Description Barn with a gambrel roof and a concrete foundation.

Condition good
Integrity good

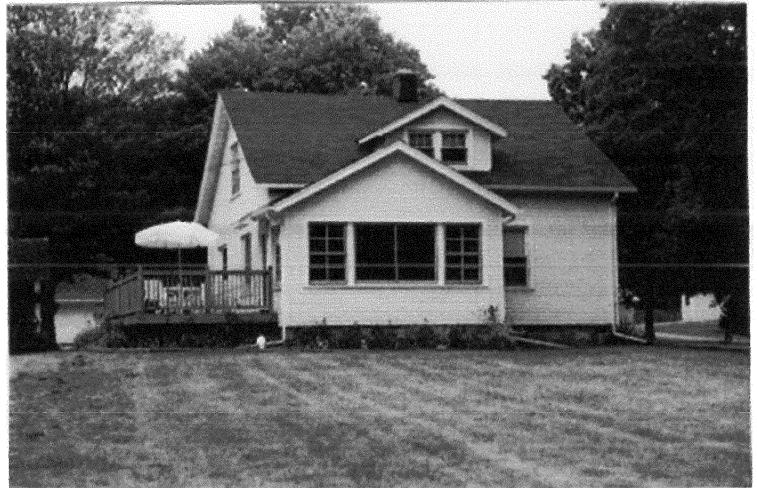
23. Residence

Description One and one-half story house with an enclosed front porch and a dormer. The house sits on a rubble stone foundation, a foundation style which does not fit with the construction date of house. Perhaps the current house was built upon the foundation of an earlier home, or the stone of an earlier home was re-used to build this foundation. A house had existed on this property as early as 1872 (township plat map-1872). Another explanation could be that the construction date actually reflects a renovation date, indicating that major renovations of the structure occurred in 1934.

Condition house-good; farm structures-good
Integrity house-good; farm structures-good

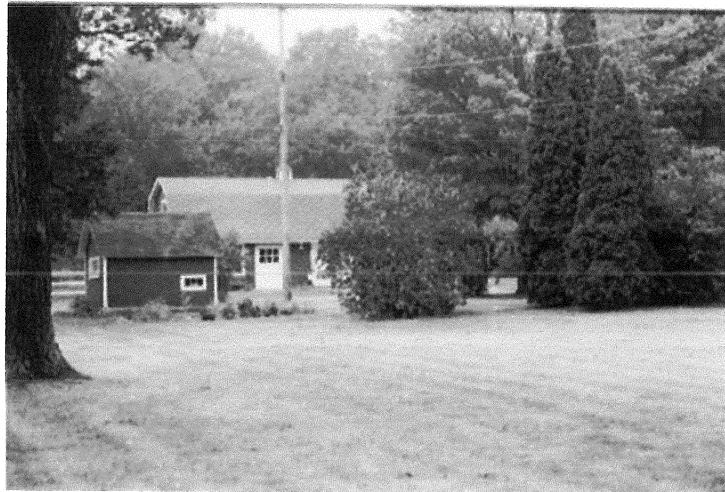
24. Barn and small outbuilding

Also located on the property are a small barn with gambrel roof and an additional small farm structure.

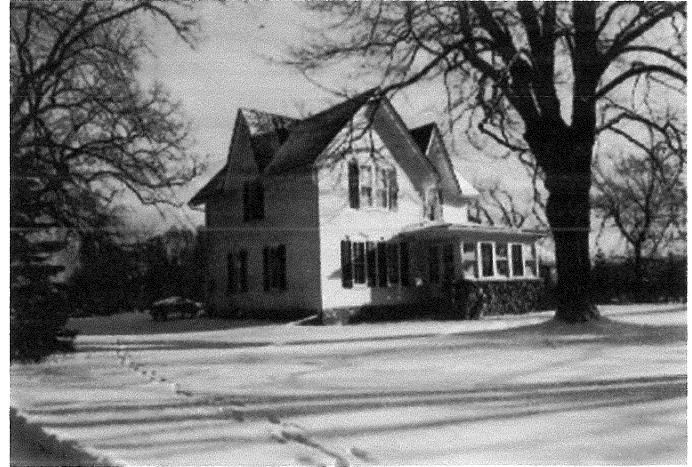
25. Residence

Description Two-story L-plan Gothic Revival house with a dominant front gable and several distinctive gable dormers. The house sits on a rubble stone foundation and has decorative window crowns. A one-story addition stands on the east side of the house. According to the WPA Rural Property Inventory, anachronistic enclosed front porch, with rubble stone half walls, was added to the house prior to 1939.

Condition house-good; barn-good

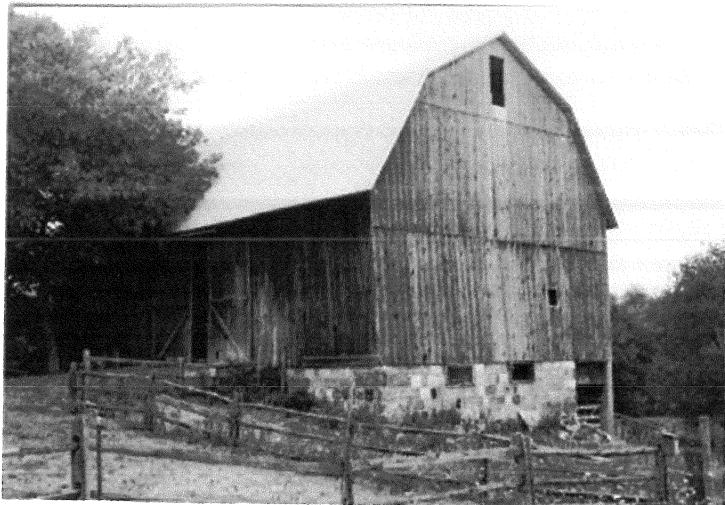
21. Barn

Also located on the property is a barn with a gambrel roof and stone foundation, and a newly constructed two-car garage with double dormers, that replaced the original garage built in 1889. Today the property contains over thirty acres, with several landscape remnants remaining from the original farm including mature shade and fruit trees, fence rows, and an open field. The owner raises a small herd of llamas.

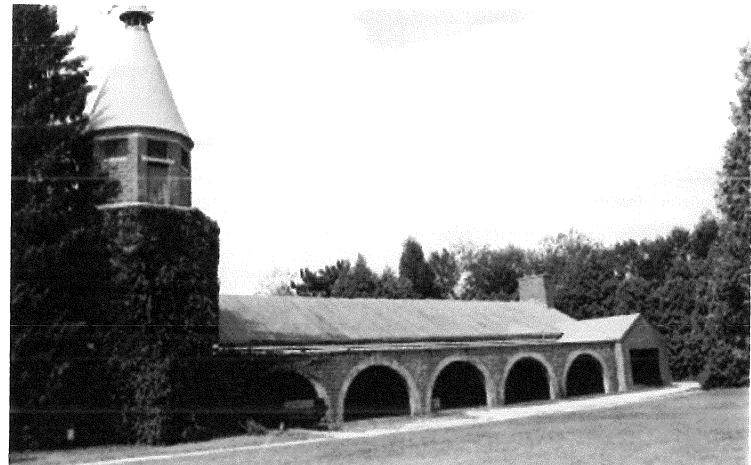
5. Brady Lodge

Description Boy Scout Lodge constructed of concrete block with red brick trim. This large building has an impressive circular tower, topped in copper. Also associated with the Boy Scout camp and located on the site are a concrete block garage (same block type as those used on the lodge) and four small log cabins. In 1937, the scout camp comprised 28.5 acres.

Condition all buildings-good to fair
Integrity all buildings-good

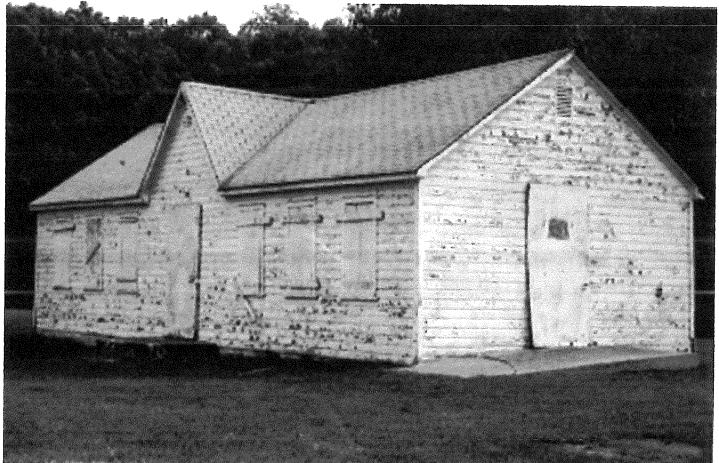
29. Wood frame building (2 of 2)

There are several other buildings located on the old camp property, these were probably constructed by the Boy Scouts after 1937, or were built by the church group that purchased the camp from the Boy Scouts ca. late 1940s. These buildings include: one small log building; three similar wood frame buildings with concrete foundations, two with cross gables; one wood frame building with a concrete foundation and vinyl siding; one small wood frame building with a concrete post foundation and aluminum siding; one larger wood frame building with a covered porch and a brick chimney.

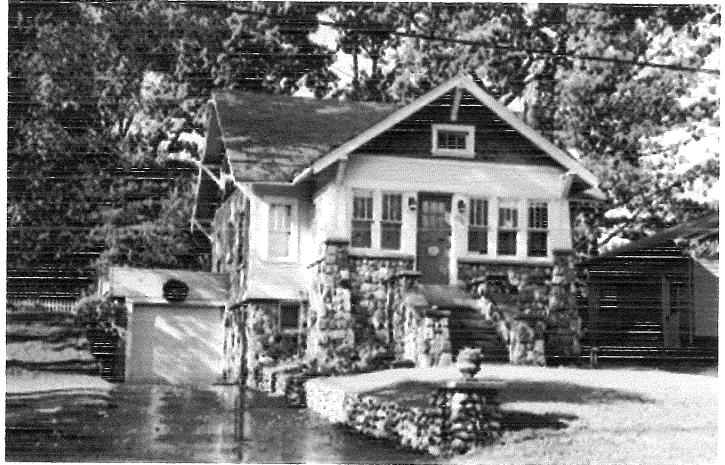
Description Craftsman style bungalow with an enclosed front porch, rubble stone half-walls and chimney, decorative braces under the eves, and wood-shingled gables. An additional rubble stone wall is located along the east side of the driveway. Attached to the house is a one car garage.

Date of Construction 1930
Condition good
Integrity good
