INDEPENDENCE TOWNSHIP INVENTORY

Address 6315 Balmoral Terrace

Site No. 32-03
Sidwell No. 08-32-427-010

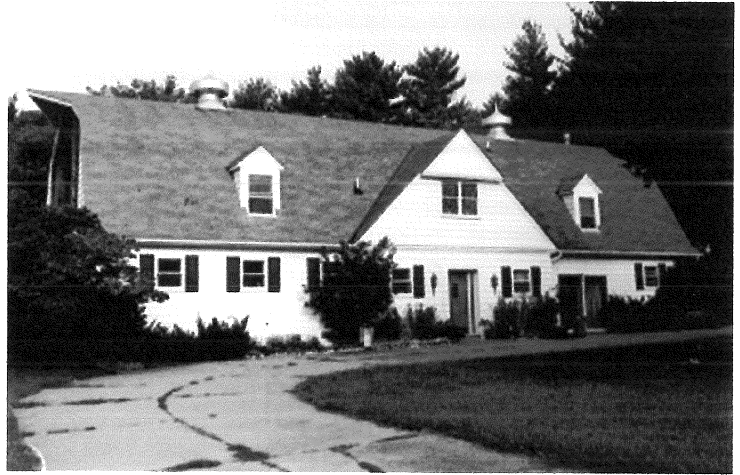
16. Residence (renovated barn)

Description Located on this site is a large barn with a gambrel roof that has been converted into a residence, a concrete block four-car garage with a gable roof and a concrete block storage building with a gable roof.

Date of Construction barn/house- 1970 (township tax records- probably a remodel date); concrete block structures-unknown
Condition barn/house-good, concrete block structures-good
Integrity barn/house-fair, concrete block structures-good

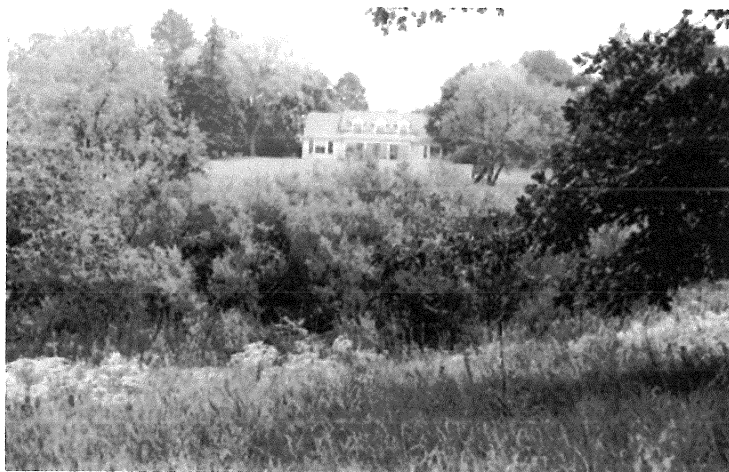
3. Residence

Also located on the property, and observed during the 1998 survey, is a house (viewed and photographed at a considerable distance) and two stone entrance pillars, located along Clarkston Road.

Date of Construction house-1925 (1950 remodeled); farm structures-unknown
Condition all structures-unknown
Integrity all structures-undetermined

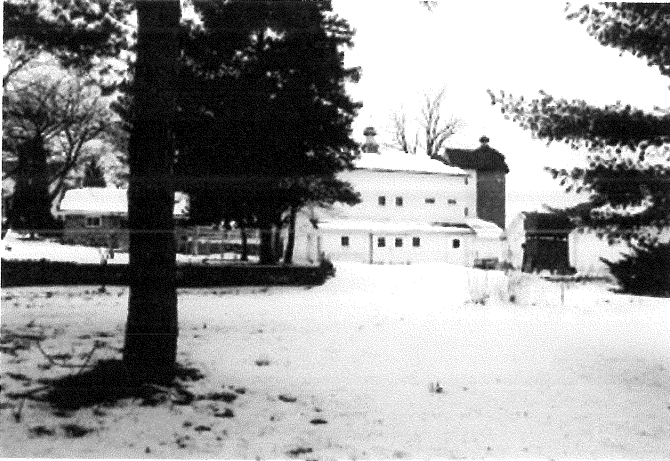
7A. Barn complex and silo

Description Five farm structures are located on the property including: a rubble stone outbuilding with a gable roof; a large wood frame barn, painted white with horizontal siding and a concrete block foundation; a small wood frame outbuilding with a gable roof and horizontal siding; a moderately sized outbuilding similar to the first two buildings describe; and a rubble stone wall about two feet high, possibly apart of the foundation of a barn. (Because access to the property was prohibited [locked gate] the descriptions of the farm structures were taken directly from the 1991 Historic Structures Survey).

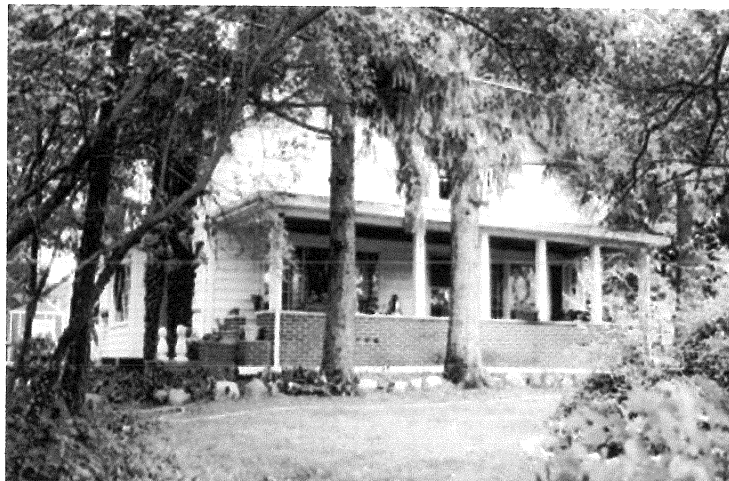
Description Two-story square house with a gable roof, a cement foundation, anachronistic exterior siding and a covered porch with brick half-walls.

Date of Construction 1915
Condition good
Integrity undetermined

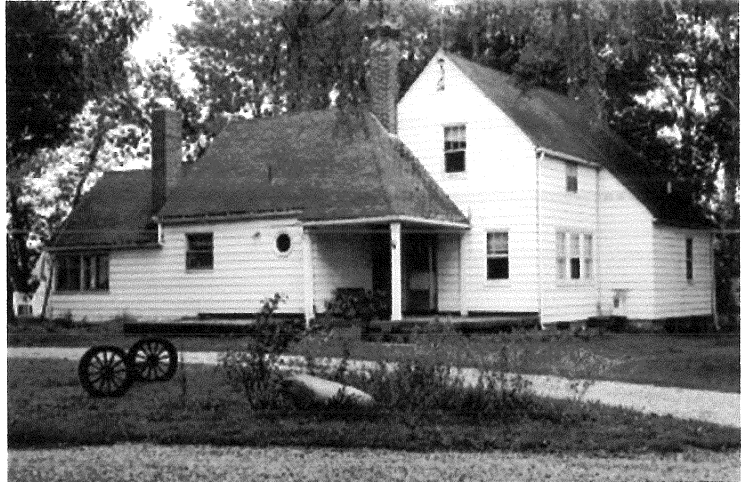
23. Residence

Description The structure of this house has changed considerably since it was described in the WPA Properties Inventory in 1939. At that time, the house was a two-story structure with a rubble stone foundation and a gable roof. Attached to the main structure was a one-story wing. All additional sections have been added since 1939. The house is covered with anachronistic siding.

Date of Construction house-1930 (WPA Rural Properties Inventory - This date probably represents a remodel date, the stone foundation indicates that the structure is older than 1930); barn-1898 (remodeled in 1936); silo-1928; small outbuilding-unknown; garage-unknown

Condition house-good; barn-good; silo-fair (cap missing); small outbuilding-poor; garage-good
Integrity house-poor; barn-good; silo-fair; small outbuilding-poor; garage-good

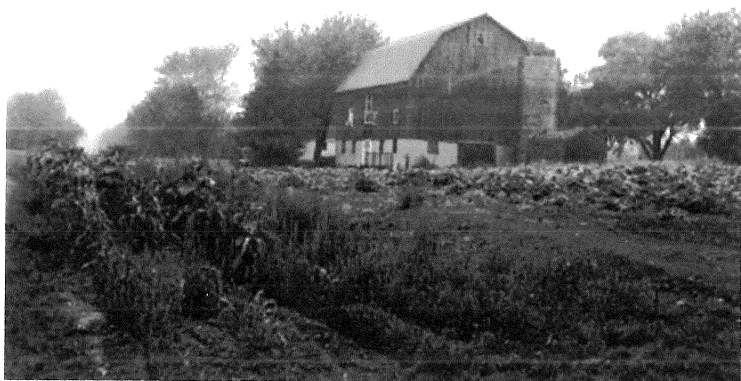
22. Barn, silo and small outbuilding

Also located on the site is a barn with a concrete foundation and gambrel roof, a tile silo and a small outbuilding, and a two-car detached garage.

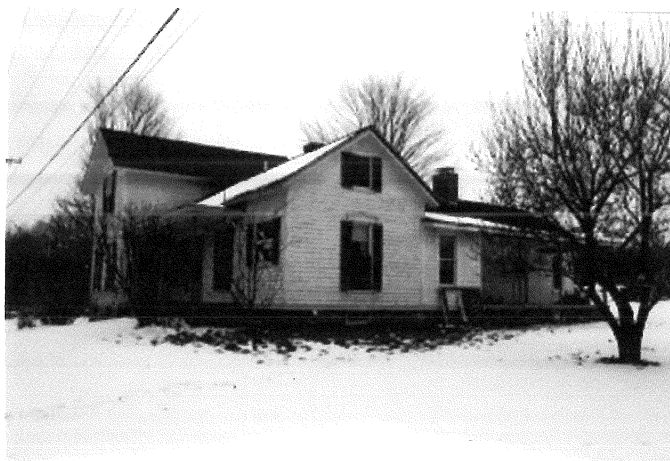
Description Gable-front-and-wing house with a rubble stone foundation, decorative window crowns and a one-story addition to the rear, built prior to 1939 (WPA Rural Properties Inventory). The house is partially covered with anachronistic siding and the front porch has replacement roof supports.

Date of Construction 1899 (remodeled in 1915)
Condition good
Integrity fair

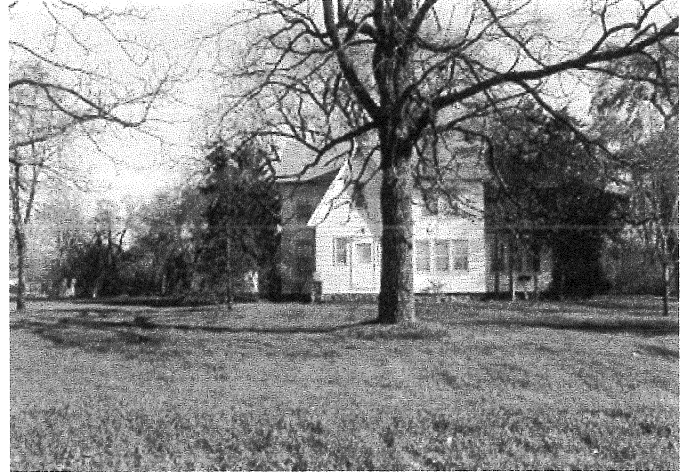
Description Two-story rectangular house with a rubble stone foundation, a gable roof and a Tudor style entrance porch, probably a later addition. A flat-roofed addition stands to the east (with balustrades) and acts as a roof balcony. The house has anachronistic siding and windows.

Date of Construction 1885 (1991 survey-reference unknown), 1928 (WPA rural inventory, possibly a remodel date)
Condition good
Integrity undetermined

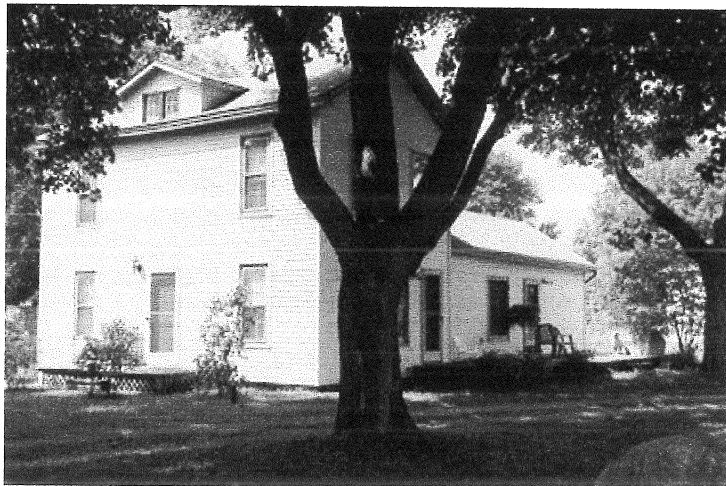
Description Two-story house with a dormer window, anachronistic vinyl siding, and a one-story addition to the rear. The house does not resemble the floor plan drawn in the 1939 WPA Rural Properties Inventory. It is uncertain if this reflects major changes in the structure (i.e. two-story vs. one and one-half story), or if the wrong structure was identified in the 1939 rural inventory.

Date of Construction unknown
Condition good
Integrity undetermined

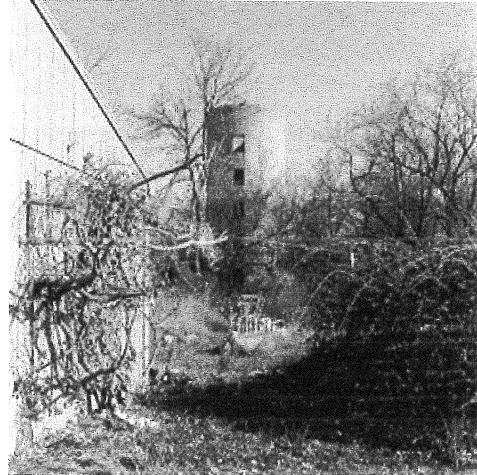
Description Located on the site is a concrete silo and a rubble stone foundation of a barn, which has been incorporated into the construction of a contemporary house.

Date of Construction silo-unknown, barn-unknown
Condition silo-fair (no cap); barn-ruin
Integrity silo-fair; barn-poor

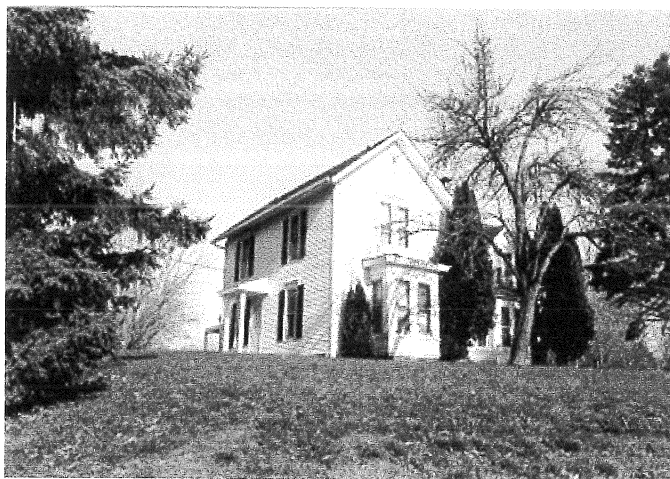
Description Two-story L-plan house with a stone foundation, two bay windows, and attenuated windows with decorative window crowns. The facade has two front-gables, with a decorative "S" located in the secondary gable (presumably for "Sibley", the family that owned the house in the late 1800s and early 1900s). The house has anachronistic siding, and several additions, built prior to 1939 (shown on the WPA Rural Properties Inventory).

Date of Construction 1884 (WPA Rural Properties Inventory), 1864 (1991 survey-reference unknown)
Condition good
Integrity good

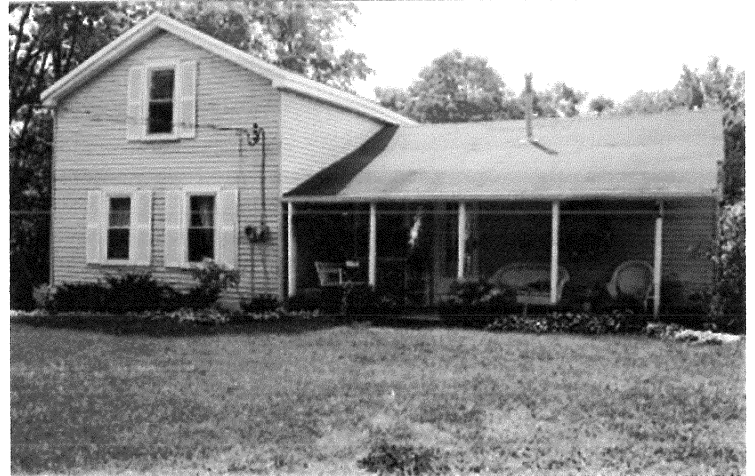
Description Gable-front-and-wing house with a rubble stone foundation. According the owner, the original configuration of the house has changed, due to a fire in the kitchen twenty years ago and subsequent reconstruction. Hand hewn rafters are found within the original section of the house. Anachronistic features include the decorative shutters and the exterior siding.

Also located on the site is the foundation of an outhouse (front of house), a dump area (front of house) and a foundation of a barn (maybe on adjacent property).

Condition house-good; farm structures-ruins
Integrity house-poor; farm structures-poor

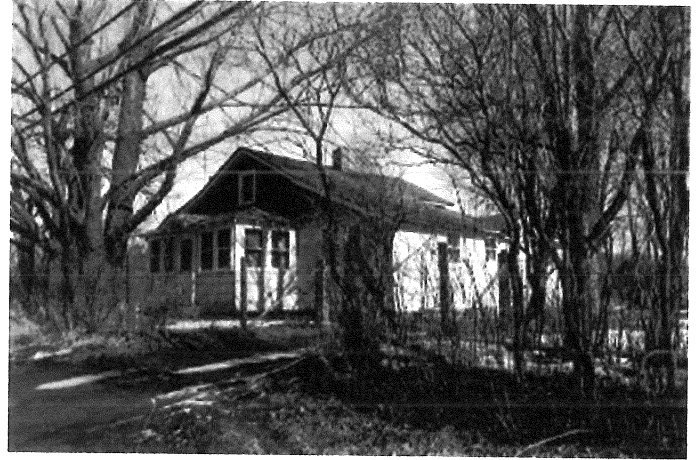
20. Residence

Description Rectangular one and one-half story house with a gable roof, an enclosed porch, and a one-story addition to the south.

Date of Construction house-1837 (remodeled in 1938); outbuilding-unknown
Condition house-good; outbuilding-fair
Integrity house-poor; outbuilding-undetermined

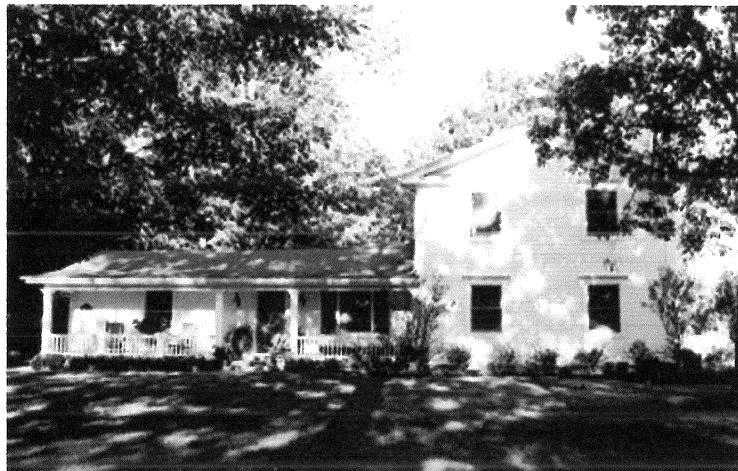
Description Gable-front-and-wing house with anachronistic siding.

Date of Construction unknown
Condition good
Integrity undetermined

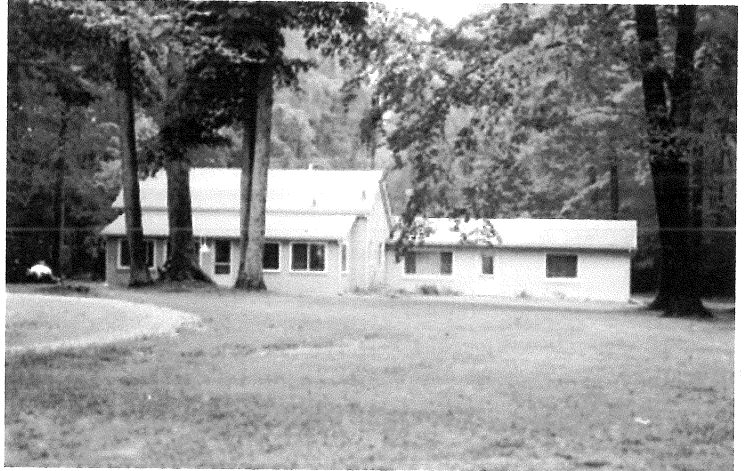
Description One and one-half story rectangular house with a gable roof and a concrete post foundation. Anachronistic changes to the house since 1939 (WPA Rural Properties Inventory) include the enclosure of the front porch and the construction of a one-story addition to the south.

Date of Construction 1930
Condition good
Integrity fair

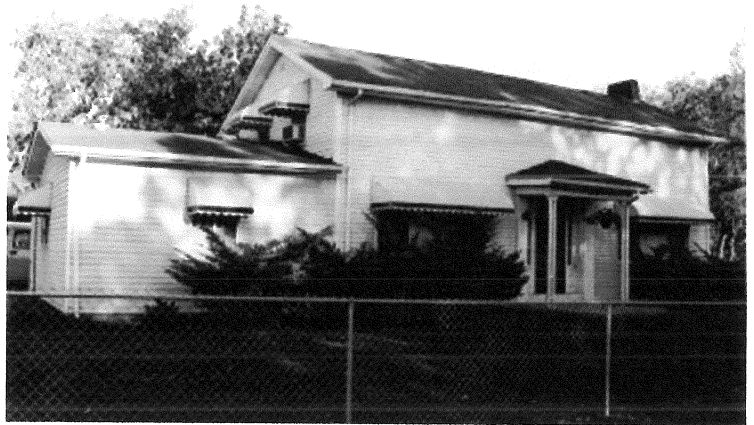
Description The house has the basic shape and roof pitch of a side-gabled Greek Revival houses that were typically constructed throughout the township. Anachronistic changes to the structure including windows, decorative shutters, metal awnings and exterior siding.

Condition good
Integrity poor

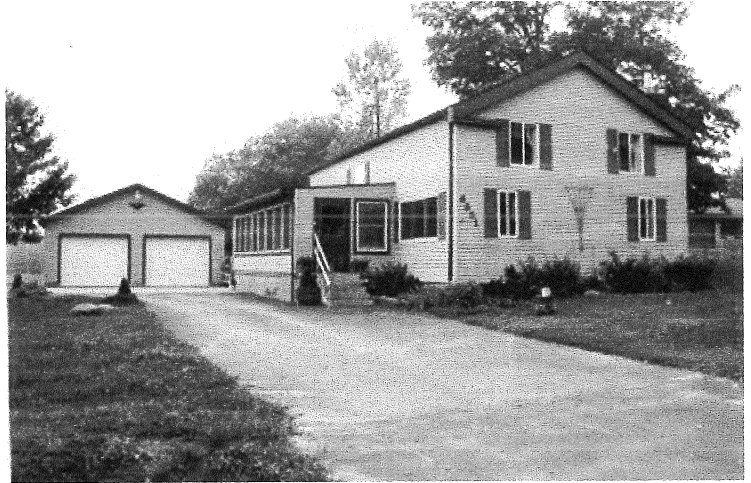
Description Front-gabled Greek Revival house. Anachronistic changes to the structure include a concrete foundation, an enclosed porch, decorative wood shutters, and aluminum siding and windows. The house lacks the wide trim band which typically emphasizes the cornice lines of Greek Revival houses.

Date of Construction house-1837, remodeled in 1913 (WPA Rural Properties Inventory)
Condition good
Integrity poor

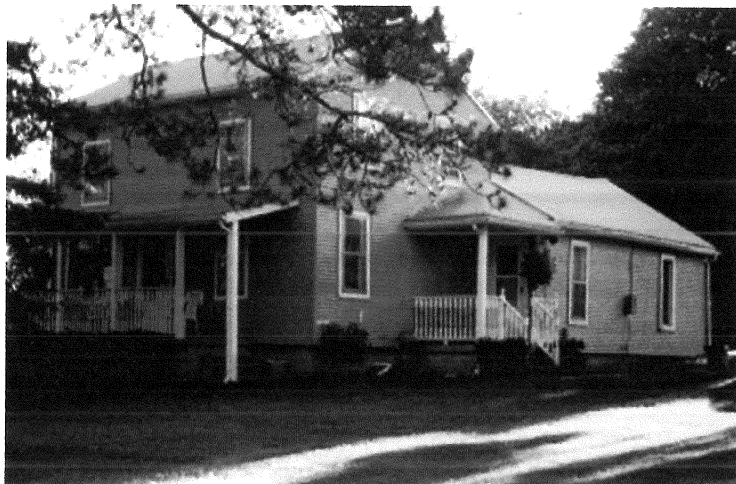
Description Two-story rectangular plan house with a concrete block foundation, a gable roof and a one-story addition to the rear. The house has anachronistic exterior siding.

Date of Construction 1875
Condition good
Integrity fair

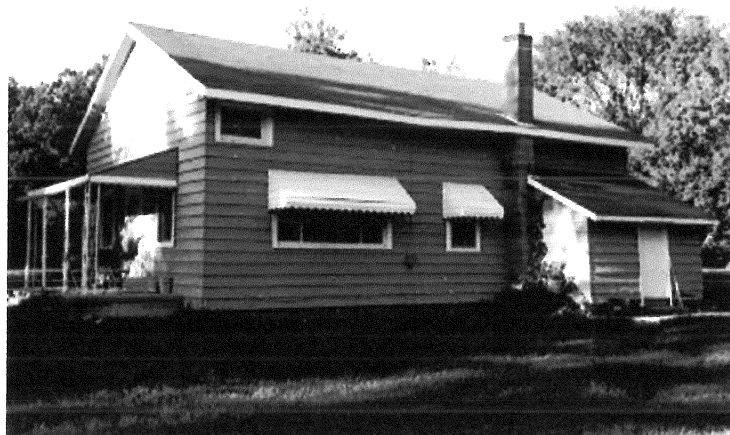
Description Wood frame schoolhouse with many anachronistic changes including a concrete block chimney and aluminum window awnings and exterior siding.

Date of Construction ca. 1840
Condition good
Integrity fair

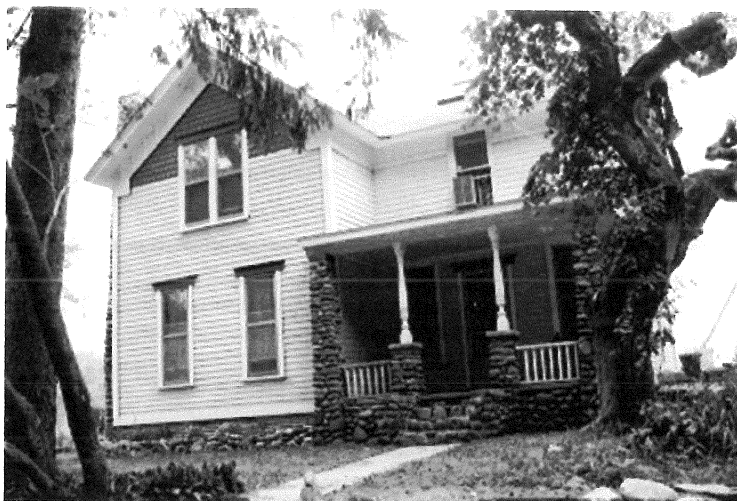
Description Two-story house with a concrete foundation, a gable roof and a covered front porch. The porch and the chimney, constructed of rubble stone, were probably renovations made during the 1920s or 1930s.

Also located on the property is a concrete block detached two-car garage with gambrel roof.

Date of Construction house-1890; garage-unknown
Condition house-good; garage-good
Integrity house-good;
