## INDEPENDENCE TOWNSHIP INVENTORY

**Address** 5285 Oak Hill Rd

**Site No.** 02-02  
**Sidwell No.** 08-02-100-006

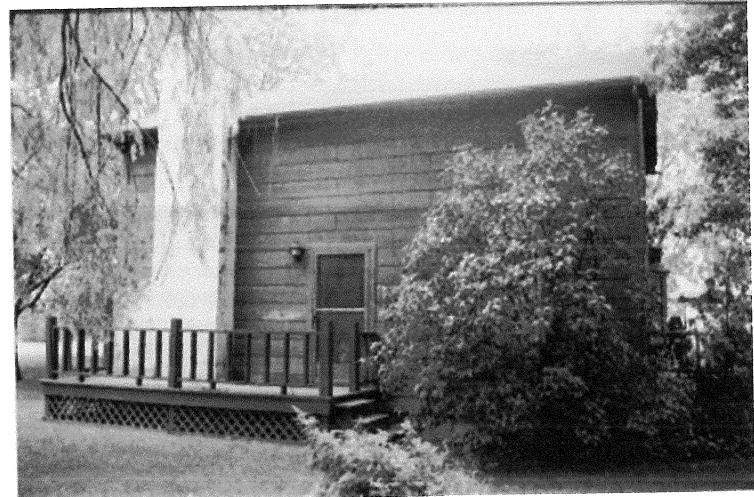
22. Residence

**Description** It appears that the original facade of the house, which would have faced Oak Hill Road, has been severely altered. Today the primary entrance to the house is on the west side, along the one-story addition. Other anachronistic changes to the house include a concrete chimney, several wooden decks and horizontal wood siding.

**Condition** house-good; farm structures-good  
**Integrity** house-poor; farm structures-good

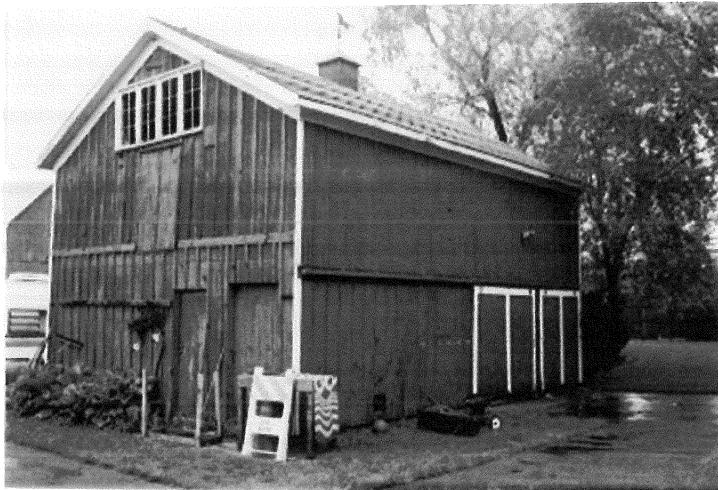
18. Carriage house

Farm structures associated with the home include a large barn with a stone/concrete foundation and gambrel roof; a smaller outbuilding with gable roof, referred to by a family member as the carriage house; a milk house; two concrete silos (Smith Silo Co. of Oxford Mi.); and several smaller outbuildings, including a several attached to the main barn.

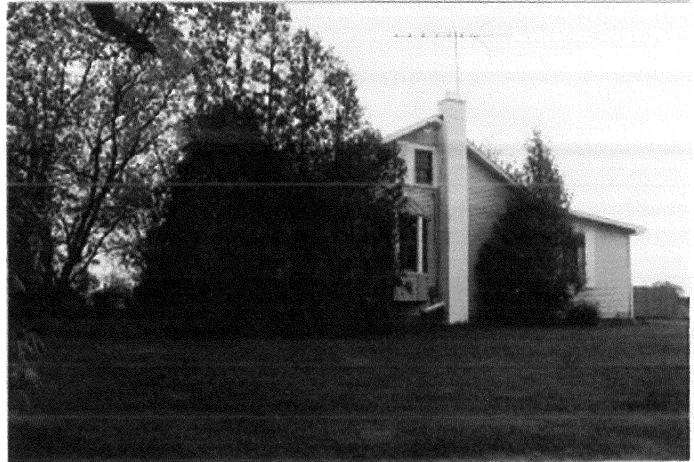
**Description** One and one-half story vernacular farmhouse with anachronistic siding and an exterior chimney. The WPA Rural Property Inventory describes the house as a one-story building with a ten foot lean-to. If the description in the report is accurate, than a second floor has been added since 1939.

**Date of Construction** 1910 (township tax records), 1926 (WPA Rural Property Inventory)  
**Condition** good  
**Integrity** undetermined - excessive vegetation

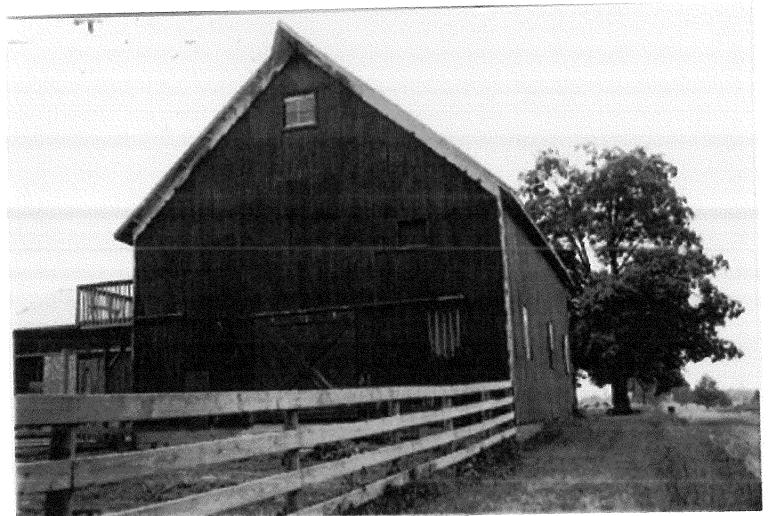
3. Barn (1 of 2)

**Description** There are two barns on the property, both with gable roofs. One barn has an asphalt roof and a concrete foundation, the other has a metal roof, its foundation was not visible. According to the WPA Rural Property Inventory, in 1939 a farm was located at the northeastern corner of Perry Lake and Oak Hill Roads. The farmstead was approximately four and a half acres and its main entrance was on Perry Lake Road, south of the extant barns. The inventory indicates that there were several barns associated with the property-two general barns with gable roofs built in 1880, one with a stone foundation and one with a concrete foundation; and a dairy barn. Typically barns are located in the general area of the farmhouse; however, it is possible that the extant barns, accessed from Oak Hill Road, were associated with the 1939 farmstead.

**Condition** good  
**Integrity** good

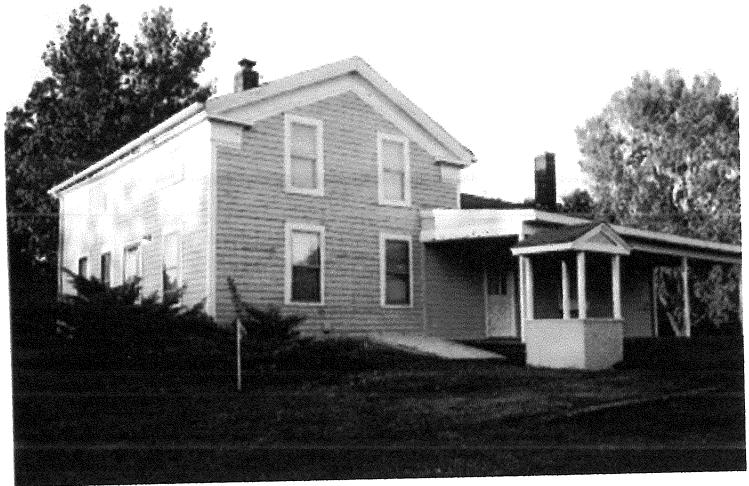
**Description** Side-gabled Greek Revival house with clapboard siding and a pair of frieze band windows. A one-story addition was constructed to the rear of the house. Also located on the site is a stone lined well.

**Condition** good  
**Integrity** good

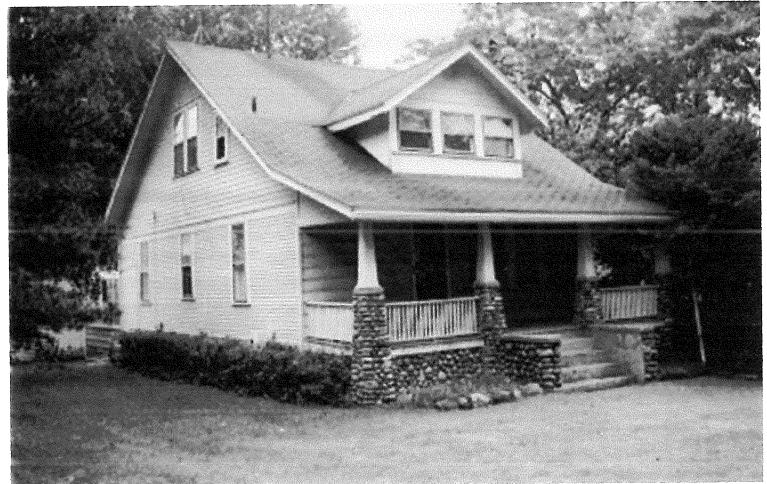
**Description** One and one-half story bungalow with a gable roof (with dormer) and a covered front porch. The front porch, as well as the chimney on the south side of the house, are constructed of rubble stone.

**Condition** good  
**Integrity** good

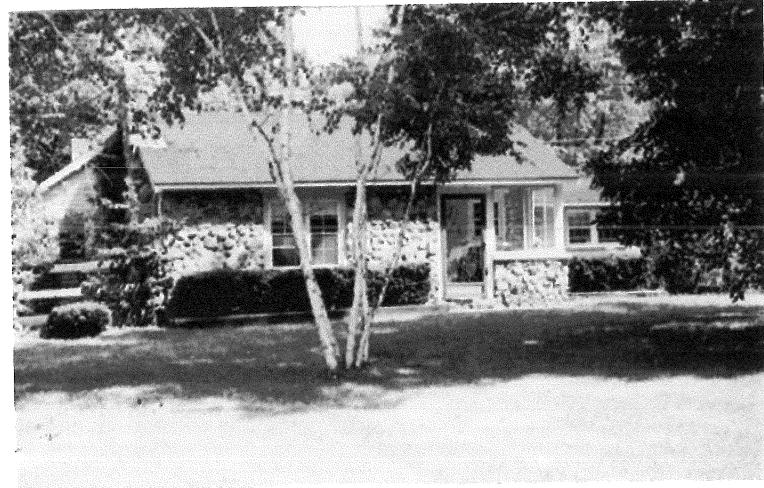
**Description** One-story house with a rubble stone facade and chimney.

**Condition** good

**Integrity** good

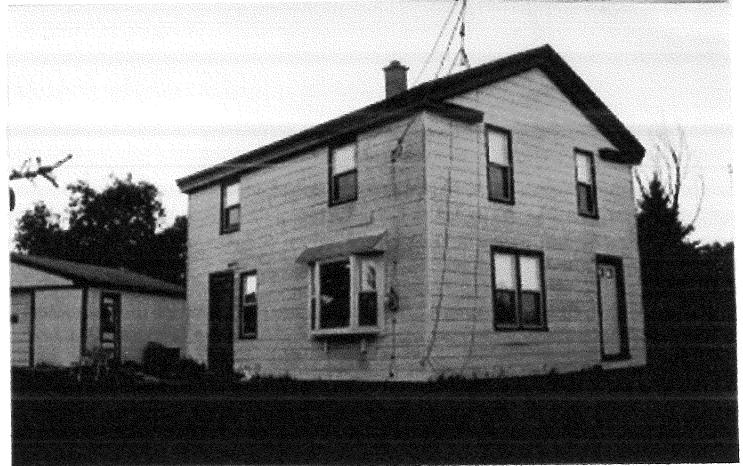
**Description** Front-gabled house with many anachronistic changes including the concrete foundation, exterior siding, window replacements and relocations, and a small bay window.

**Date of Construction** 1880 (township tax records), 1938 (WPA Rural Property Inventory-remodel date or mistake for 1838?)  
The returned cornice treatment of the front gable, and the pitch of the roof indicate that this house might date from the Greek Revival era, however, there have been many exterior changes, making the structure difficult to date.

**Condition** good  
**Integrity** poor

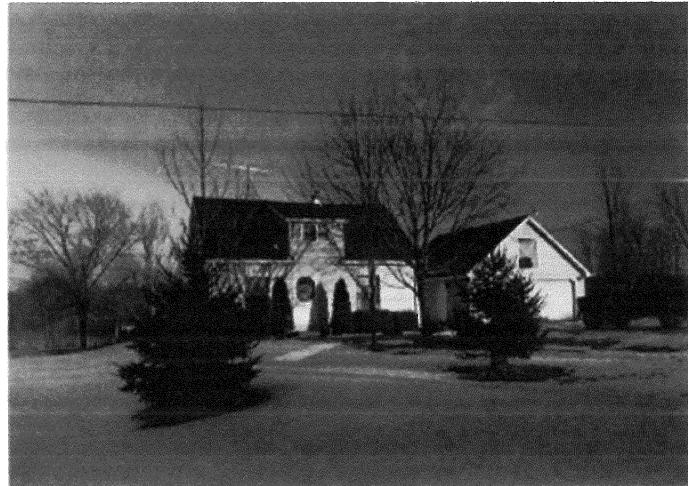
**Description** One and one-half story side-gabled house with a cement block foundation. A two-car detached garage stands to the south of the house.

**Condition** good  
**Integrity** good

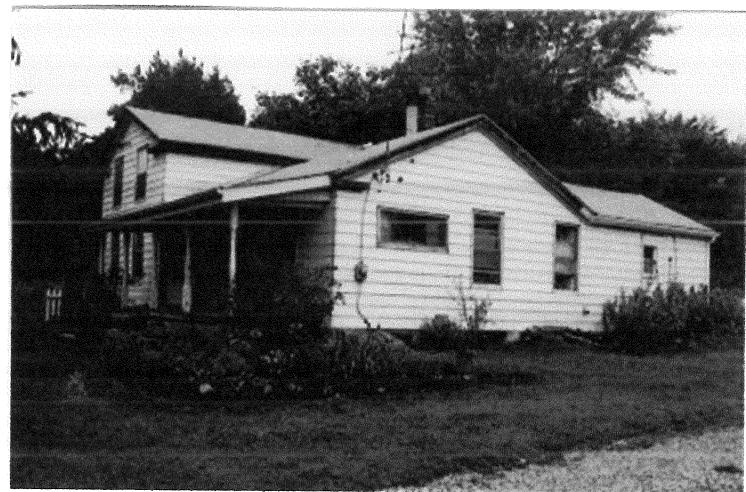
**Description** Gable-front-and-wing Greek Revival house with a rubble stone foundation, and a covered front porch. The house lacks the wide trim band which typically emphasizes the cornice lines of Greek Revival houses. Additional anachronistic changes include aluminum siding and the front porch (concrete block foundation and turned porch supports).

Also located on the property, in back of the house, are the burnt ruins of a barn.

**Condition** house-good; barn-ruins  
**Integrity** house-fair; barn-poor  
The house is located adjacent to a party store. This association detracts from the original rural quality of the property's landscape.
